**TYPE O AND ON CARRIER TELEPHONE SYSTEMS — TERMINALS AND JUNCTIONS**  
**TWIN CHANNEL UNIT LINE-UP**  
**RECEIVING REGULATOR ADJUSTMENT, RECEIVED CARRIER FREQUENCY TEST,**  
**AND ON2 FAILURE ALARM CIRCUIT ADJUSTMENT**

This section describes the tests and adjustments required in the line-up of twin channel units used in type O and ON carrier telephone systems.

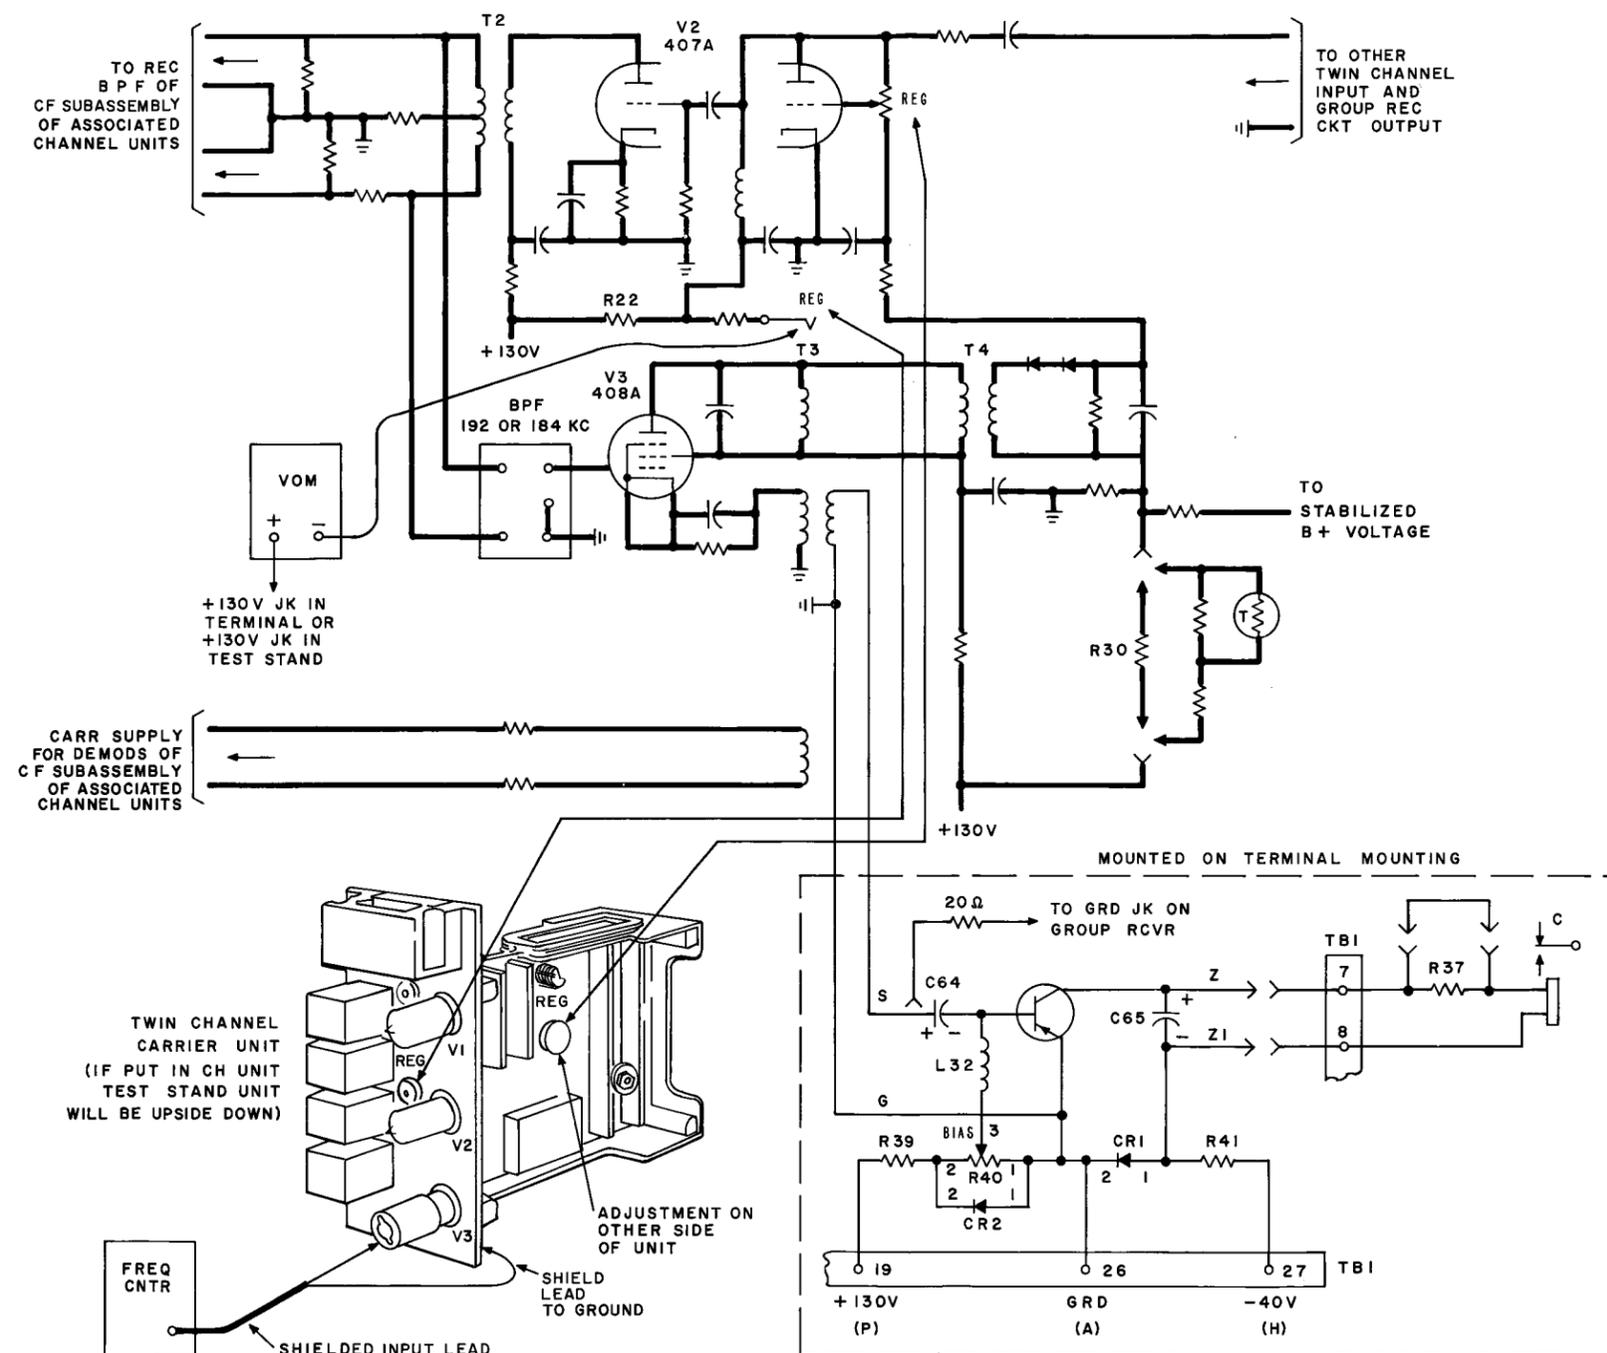
Fig. 1 — Twin Channel Unit — Regulator and ON2 Failure Alarm Circuit

| STEP | PROCEDURE |
|---|---|
| 8 | To make this measurement, the shielded input cord to the frequency counter must be equipped with a coupling device. Remove the spring from the inside of a SOS3 tube shield and connect the ungrounded side of the frequency counter input cord to the top of the tube shield (Fig. 1). A suitable alternate consists of several turns of wire solder wound into a cylinder to fit over the tube. |
| 14 | Connect a 20-ohm resistor between the GRD jack on the group receiver circuit and the positive (+) terminal of the C64 capacitor (Fig. 1). |

| STEP | PROCEDURE |
|--|--|
| 20 | In order to simulate a carrier failure and check the audible alarm, connect a 20-ohm resistor between the GRD jack on the group receiver circuit and the positive (+) terminal of the C64 capacitor (Fig. 1). When the 313C tube fires, remove the 20-ohm resistor. The CA relay should operate, bringing in a visual and audible alarm. |
